Visual Consulting
Visual Property Assessments

Examples of safety issues and structural damage found through destructive testing methods, along with examples of corrective measures.

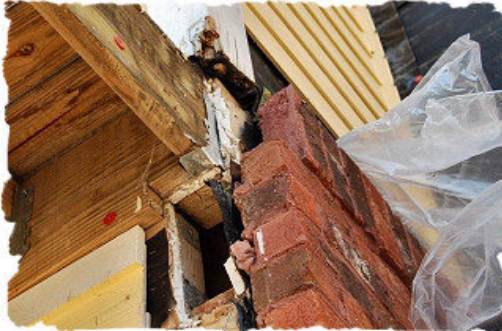
Flashing

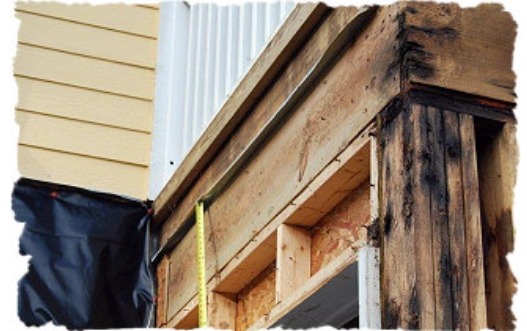
Flashing

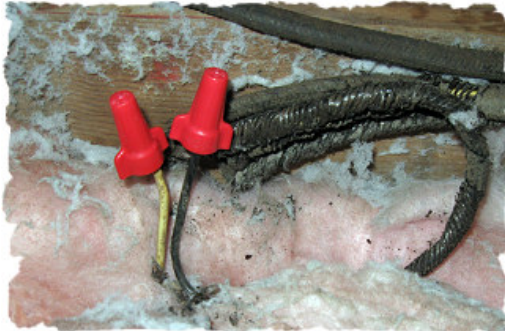
Wiring

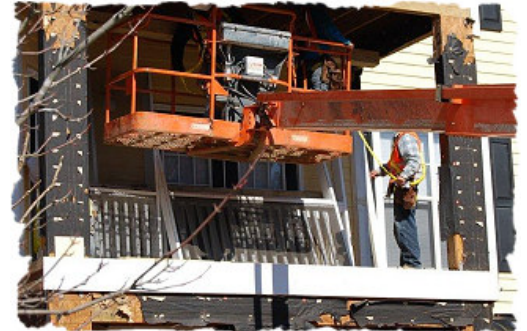
Flashing

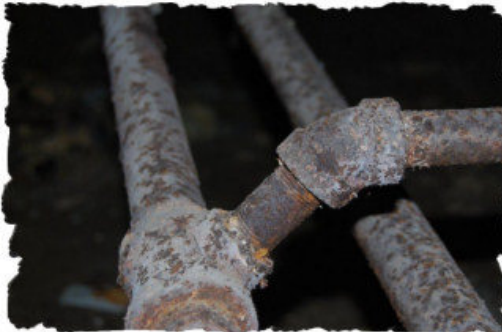
Improper Cleaning for Asbestos

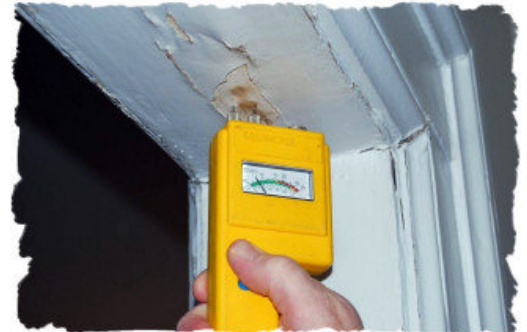
Moisture Meter Testing

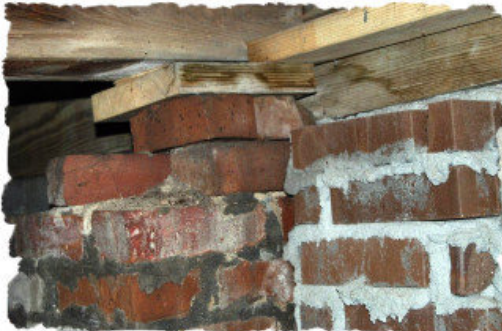
Bracing

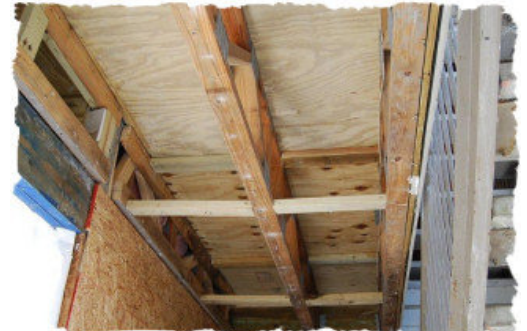
Bracing and Blocking

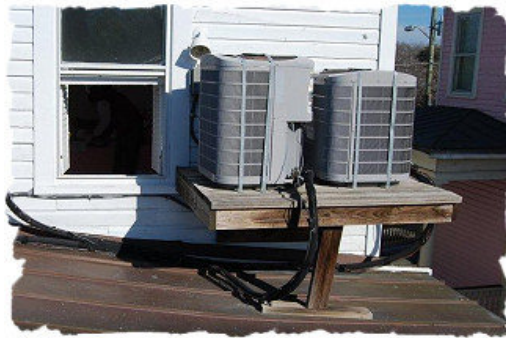
Framing

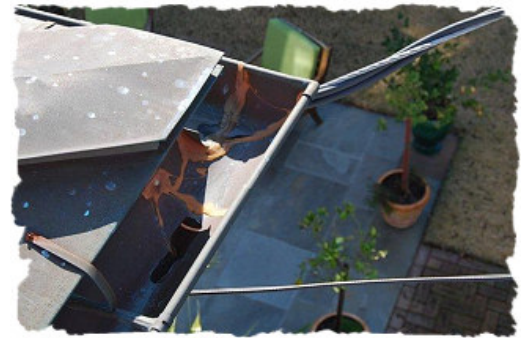
Power Line

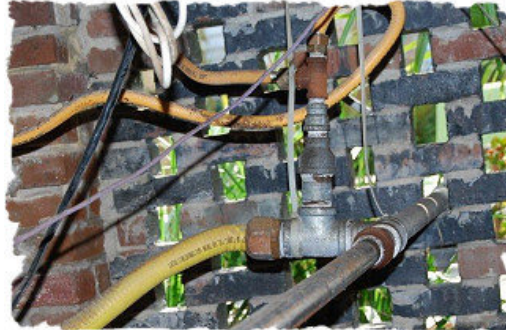
Connections and Modifications

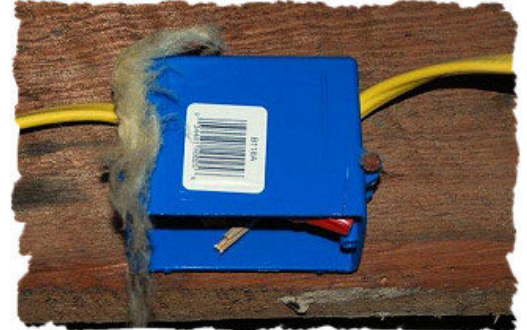
Electrical Box

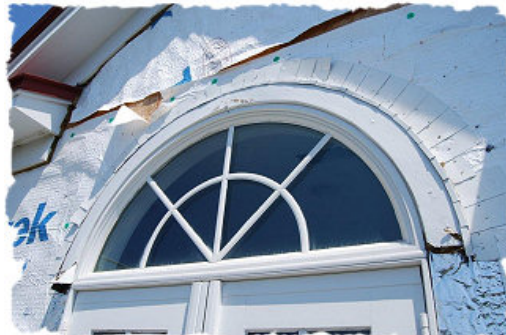
Flashing Technique

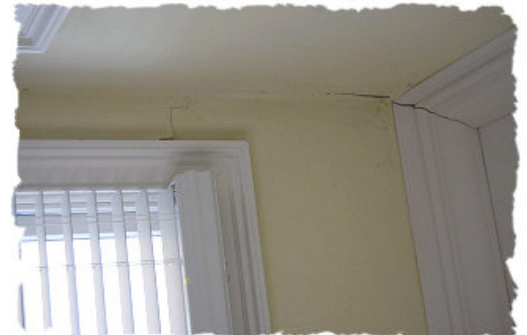
Settling and Water Intrusion

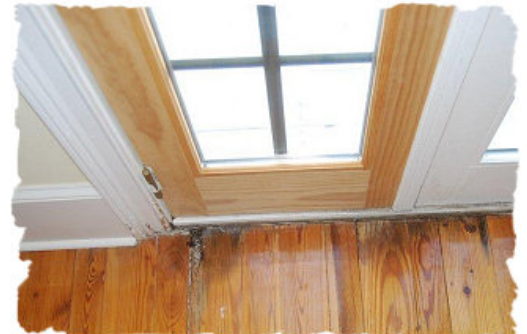
Improper Flashing & No Drain Pan Under Door

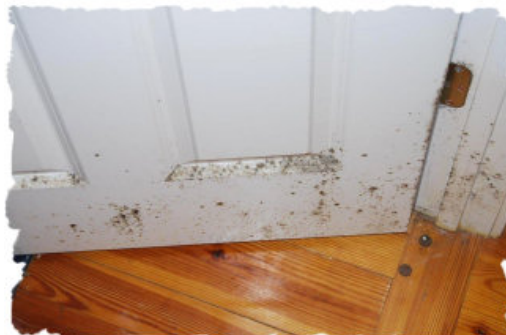
Mold From Crawl Space

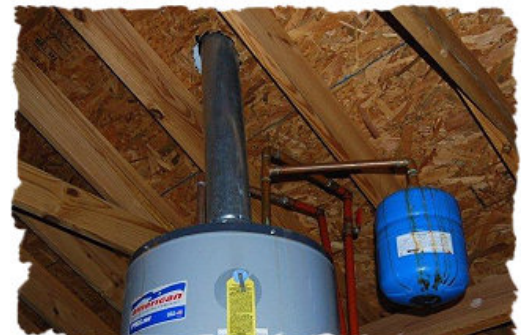
Missing Roof Vent Allows Water Intrusion
